Study on Walkability around Stations of Urban Railway in Bangkok

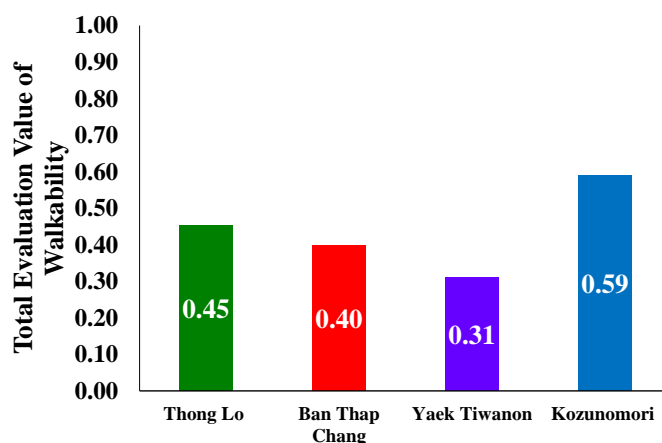
Figure 16. The evaluation result about road/sidewalk

On the sidewalks / roads, as shown in Figure 16, the results of Kozunomori station is 0.59, Thong Lo station is 0.45, Yaek Tiwanon station is 0.31, Ban Thap Chang station is 0.40 were obtained. Obstacles such as stall and street parking, status of development of the sidewalk, the width of the roads and sidewalks were mentioned as elements that influence the magnitude of walkability. Especially, the presence or absence of development of sidewalks was considered to be more important so that the total evaluation value of walkability tended to be remarkably low in the section where the sidewalk are not developed. For that reason, Yaek Tiwanon station, where sidewalks were not well developed on side roads, got a particularly low rating.

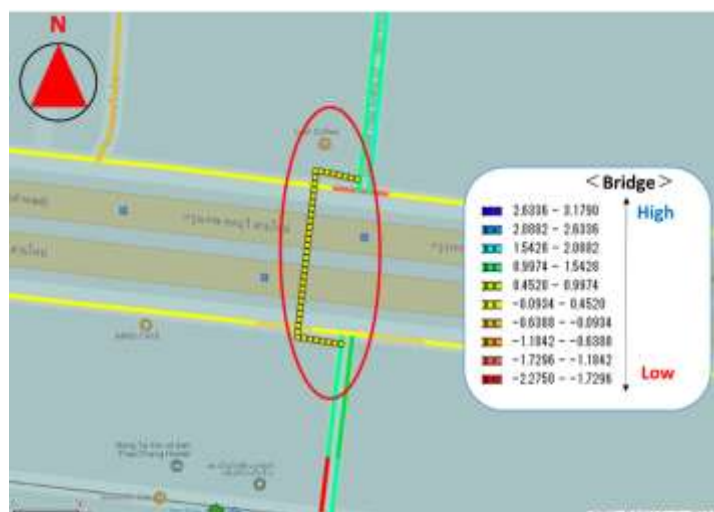
Figure 17. The evaluation result about pedestrian bridge

Pedestrian bridge exists only in Ban Thap Chang in all study areas. Equipment such as roofs and handrails has been developed for the crosswalk, and as shown in Figure 17, the total evaluation value is 0.175. The result is normal compared with the maximum value of 3.179 and the minimum value of -2.275. On the other hand, although the width of the staircase and the height of the step are important in the questionnaire, on the other hand, there are also problems that the actual width is narrow and the step is too high.

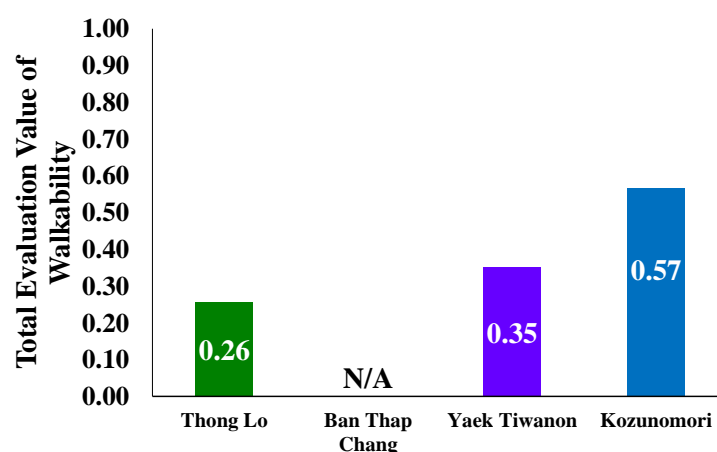
Figure 18. The evaluation result about crosswalk

On crosswalk, as shown in Figure 18, the geometric means in Kozunomori station is 0.57, in Thong Lo station is 0.26, in Yaek Tiwanon station is 0.35 and in Ban Thap Chang station is N/A. In the questionnaire, it was found that development of pedestrian traffic signal, the presence or absence of facilities considering pedestrians, and development of standby spaces in sidewalk are more important in crosswalk. Among these, the result that the development of pedestrian traffic signal is more important was obtained, so the crosswalks around Kozunomori station where many pedestrian traffic signals are being maintained became relatively high evaluation. Although there were pedestrian traffic signals around Thong Lo station as well, they did not operate normally, which caused the evaluation to be lowered. And, as the reason why the result of Thong Lo station is lower than that of Yaek Tiwanon station is the disappearance of the white line and the small number of standby space at the sidewalk are mentioned.
