## Development of Road Geometric Scanner Using Slamtec RPLiDAR A3

Louise Anne QUILAY<sup>a</sup>, Lea BRONUOLA-AMBROCIO<sup>b</sup>

<sup>a, b</sup> *Institute of Civil Engineering, University of the Philippines, Diliman, Quezon City, 1101, Philippines*

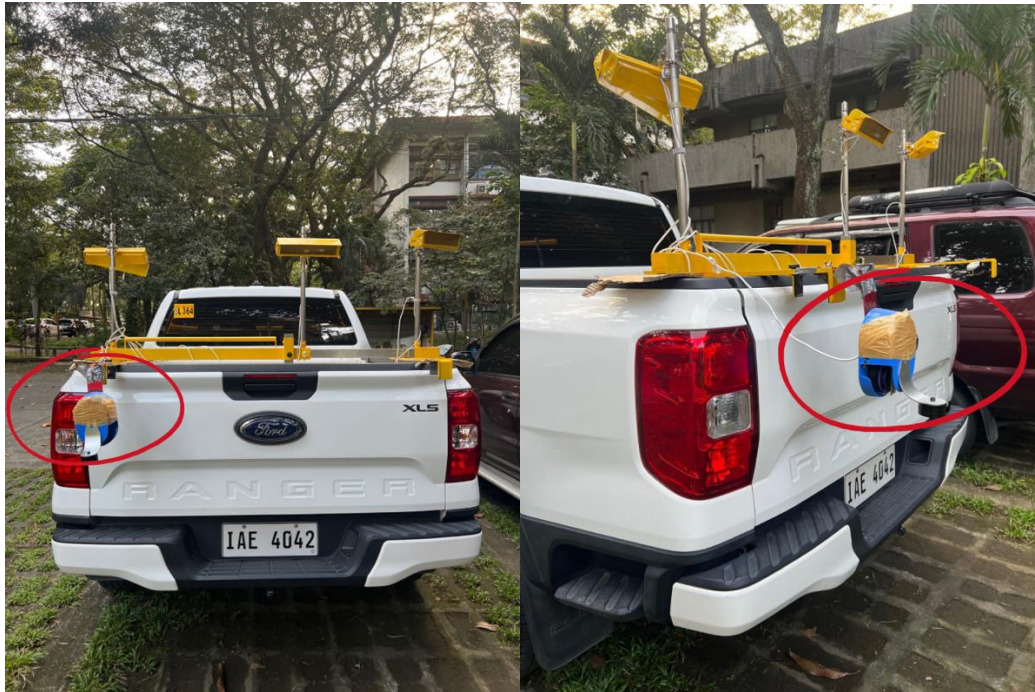
**Figure 2. Equipment Configuration**

The configuration featured the LiDAR being mounted at the back of a vehicle together with a gimbal and a camera. The problem with the LiDAR mounted at the back of a vehicle alone is that it would be leveled to the slope of the road together with the car. This problem was addressed by adding a gimbal to the configuration by eliminating the dependency of LiDAR's level to the vehicle and instead benchmark its level to the horizontal axis (0 degrees). The camera on the other hand, served as a reference which visually identified the location of a single data point.

The study utilized the Slamtec RP Lidar A3 for cross-slope measurements. This particular LiDAR device was selected due to its balance of affordability, ease of integration, and sufficient technical specifications for the objectives of this research. It offers a scanning frequency of up to 16,000 samples per second and a range of up to 25 meters, making it suitable for detailed measurements within the study's scope. When compared to other LiDAR devices used in previous studies, the Slamtec RP Lidar A3 provides a more accessible option without sacrificing necessary accuracy for cross-slope measurement. While high-end LiDAR systems might offer greater range and higher resolution, they also come with significantly higher costs and operational complexity.

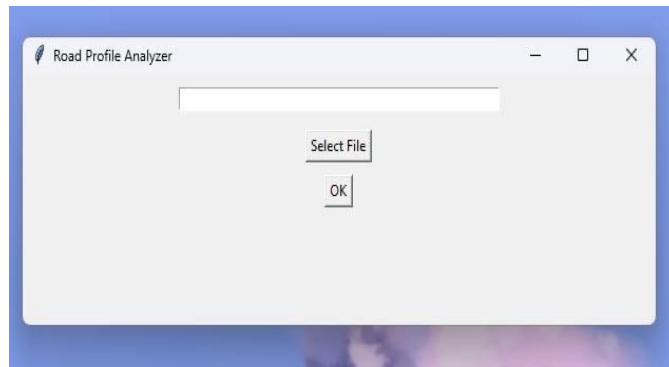
**Figure 7. User Interface of the Software**

Survey was conducted at the Academic Oval of the University of the Philippines Diliman, Quezon City using LiDAR mounted at the back of a vehicle together with a gimbal and a camera. The data collected was used as the criterion on the development of the tool. A user-friendly software that can evaluate the road geometry (cross slope, width, and longitudinal profile) was successfully developed and the user-interface of the software is shown below.

The tool is designed with a user-friendly interface to ensure accessibility. Users can run the tool by executing an .exe file and selecting the appropriate .txt file containing LiDAR data, making it suitable for use by individuals without extensive programming knowledge. This interface simplifies the process of analyzing road geometries and visualizing the results, ensuring that the tool can be effectively utilized in various operational scenarios.
