Development of Road Geometric Scanner Using Slamtec RPLiDAR A3

Louise Anne QUILAY ^a, Lea BRONUOLA-AMBROCIO ^b

^{a, b} *Institute of Civil Engineering, University of the Philippines, Diliman, Quezon City, 1101, Philippines*

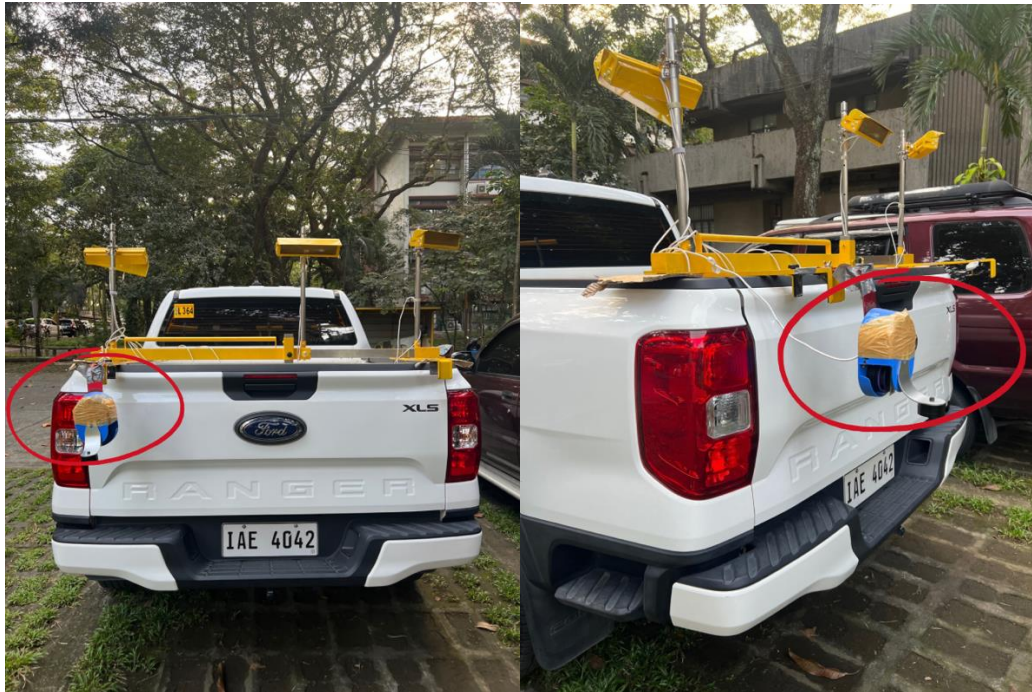
Figure 2. Equipment Configuration

The configuration featured the LiDAR being mounted at the back of a vehicle together with a gimbal and a camera. The problem with the LiDAR mounted at the back of a vehicle alone is that it would be leveled to the slope of the road together with the car. This problem was addressed by adding a gimbal to the configuration by eliminating the dependency of LiDAR's level to the vehicle and instead benchmark its level to the horizontal axis (0 degrees). The camera on the other hand, served as a reference which visually identified the location of a single data point.

The study utilized the Slamtec RP Lidar A3 for cross-slope measurements. This particular LiDAR device was selected due to its balance of affordability, ease of integration, and sufficient technical specifications for the objectives of this research. It offers a scanning frequency of up to 16,000 samples per second and a range of up to 25 meters, making it suitable for detailed measurements within the study's scope. When compared to other LiDAR devices used in previous studies, the Slamtec RP Lidar A3 provides a more accessible option without sacrificing necessary accuracy for cross-slope measurement. While high-end LiDAR systems might offer greater range and higher resolution, they also come with significantly higher costs and operational complexity.

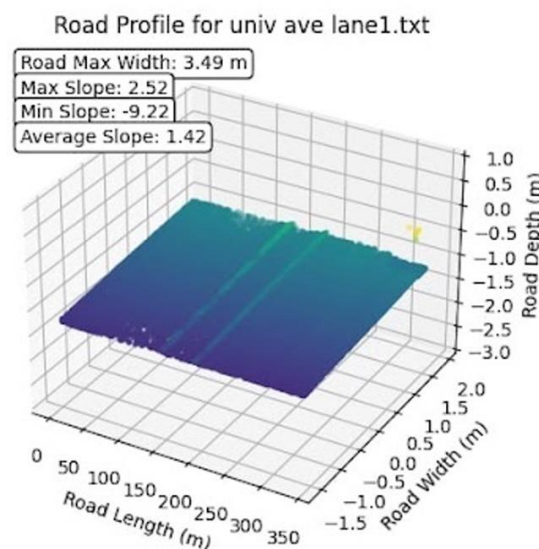
Figure 8. Road Profile of University Avenue

The tool can create a 3D diagram visualizing the profile of the road segment. Additionally, the program can identify the maximum, minimum, and average cross slopes, as well as the road width, which are considered common road geometries. It should be noted that the width presented in Figure 8 pertains exclusively to a single lane of the road, not the entire directional road width. The 3D graph is color-coded to visualize the differences in cross slopes. The sample output of the software is shown below.

The visualization of the processed data is achieved using the Matplotlib library, where a 3D scatter plot is generated. In this plot, the x-axis represents time (in seconds), the y-axis denotes the road width, and the z-axis corresponds to the road depth. Color gradients are applied to enhance the interpretation of the data, where sections of the road with a slope less than 0.02 are colored red to indicate minimal slope variation, and areas with more significant slope differences are colored green. This visual differentiation is critical for quickly identifying areas of interest, such as potential drainage issues or slope-related safety concerns.

Road width is computed by measuring the distance between the farthest points along the y-axis in the 3D plot, reflecting the physical width of the road. Cross slope calculations are performed by determining the angle between a vector perpendicular to the calculated road width and the horizontal axis, which provides an understanding of the road's lateral slope. These calculations are crucial for evaluating road safety and surface water drainage capabilities. The program computes minimum, maximum, and average cross slopes by analyzing continuous slope measurements derived throughout the dataset. These aggregated metrics provide a comprehensive overview of the road surface profile, enabling detailed assessment of road geometry variations.

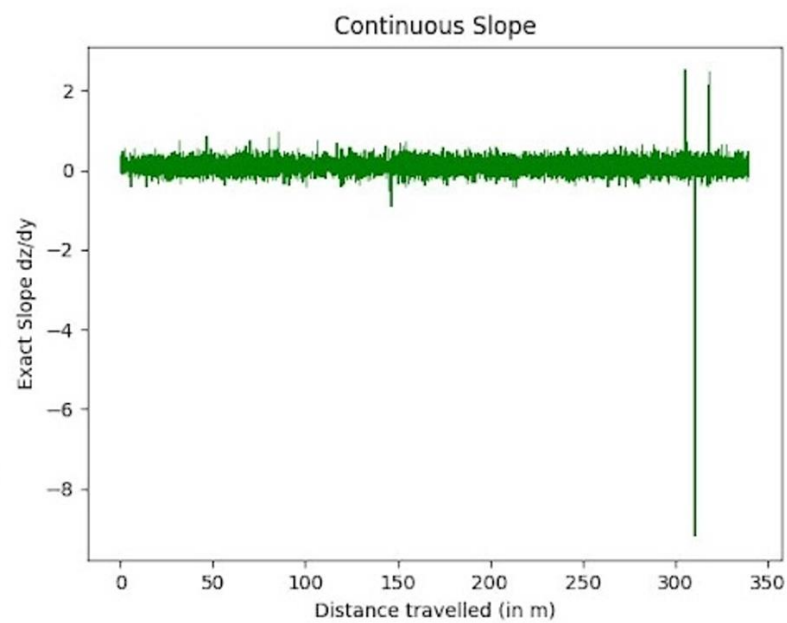
Figure 9. Continuous Slope of University Avenue

The tool can also graph the continuous slope of the road at a specific distance, as well as the average cross slope for every 20 meters shown in figures 9 and 10, respectively. Even though the data were already cleaned and filtered, there were still few outlier data as shown in figure 5. These outliers were balanced out by averaging the slope for every 20 meters for better interpretation of the cross slope of the road segment.

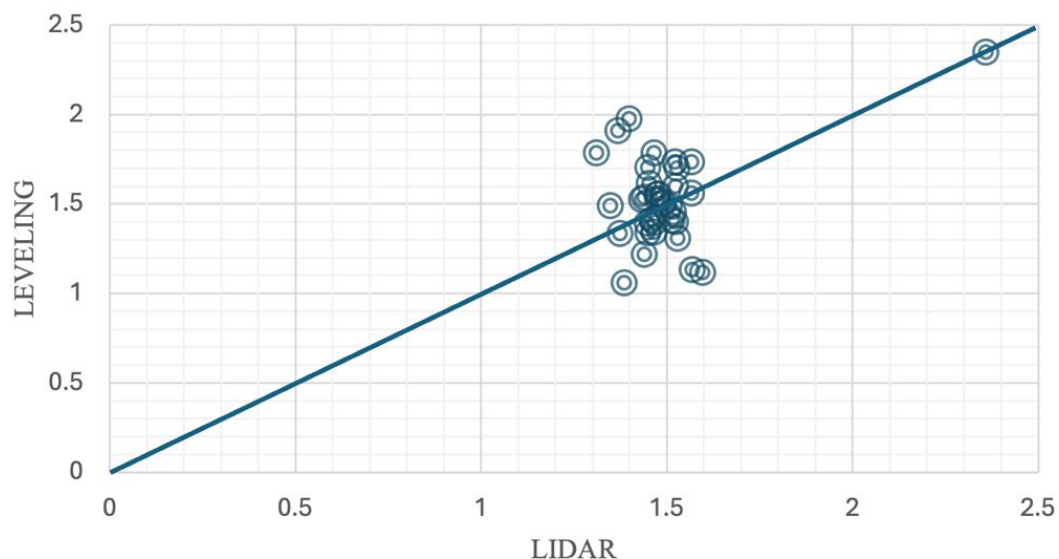
Figure 11. Relationship Between the Measured Cross Slopes Using Leveling and LiDAR

The accuracy of the tool developed was validated with the conventional method (leveling). Table 1 summarizes the cross slopes measured for every 20m along University Avenue using two different methods. The relationship of the measured cross slopes is also presented in Figure 11. The data from LiDAR range from 1.308 to 2.357 while the data from leveling have a wider range of 1.060 to 2.352. While there are values apart from the identity line, the two sets of data appear to form a cluster with one outlier. Most of the cross slopes fall on 1.5 %. The LiDAR data has an accuracy of 76.6 % with the Leveling data.

After calculating the cross slope using leveling and the developed tool, a non-parametric rank test for statistical hypothesis testing, Wilcoxon Signed-Rank Test, was used to determine whether there is a significant difference between two population means. As the computed p-value of 0.457 is greater than the significance level $\alpha=0.05$, the null hypothesis that the two samples follow the same distribution cannot be rejected. Hence, it was concluded that there is no significant difference between the two methods.

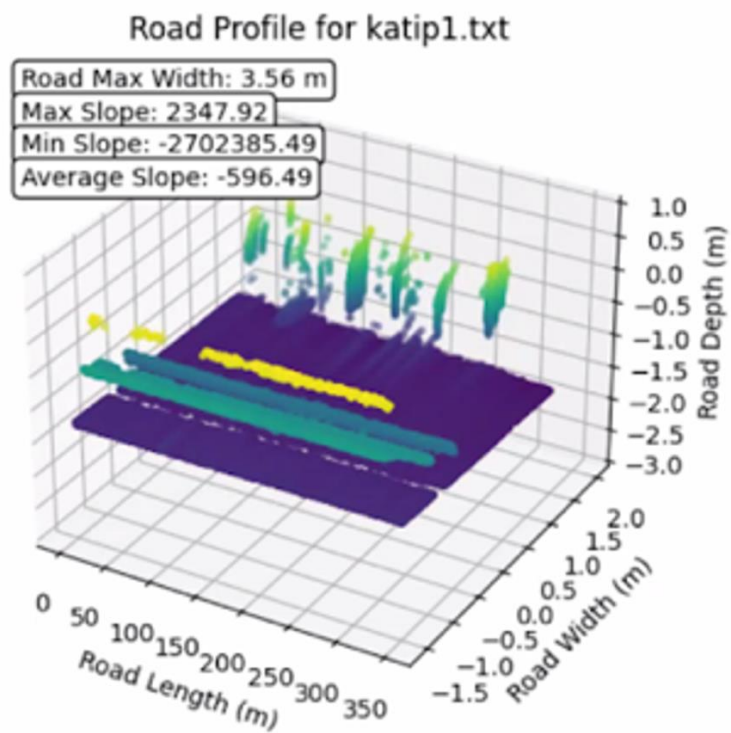
Figure 12. Sample Raw Data from Data Gathering Outside UP

These roads were tested using a different set up (different car and different gimbal from the initial data collection) to further analyze the limitations of the tool developed. Based on the results, there is a need for modification on the program even though it is user-friendly. It includes eliminating more outliers which are possibly but not limited to the following: obstruction from the car, vehicles from other lanes, etc. Sample raw data are shown in figure 12. It can be seen that a lot of unwanted data points were present aside from the road profile. Through the 3D graph, the user would be able to know which part of the data should be eliminated to further refine the measured cross slopes.
