# Assessment of Pedestrian Facilities Along Marcos Highway

J.R.F. REGIDOR, K.R.S. MARCELO and J.P.B. SALVADOR  
Institute of Civil Engineering  
University of the Philippines Diliman

**DPWH Symposium  
September 22, 2016  
GT Toyota Auditorium  
University of the Philippines  
Diliman, Quezon City**

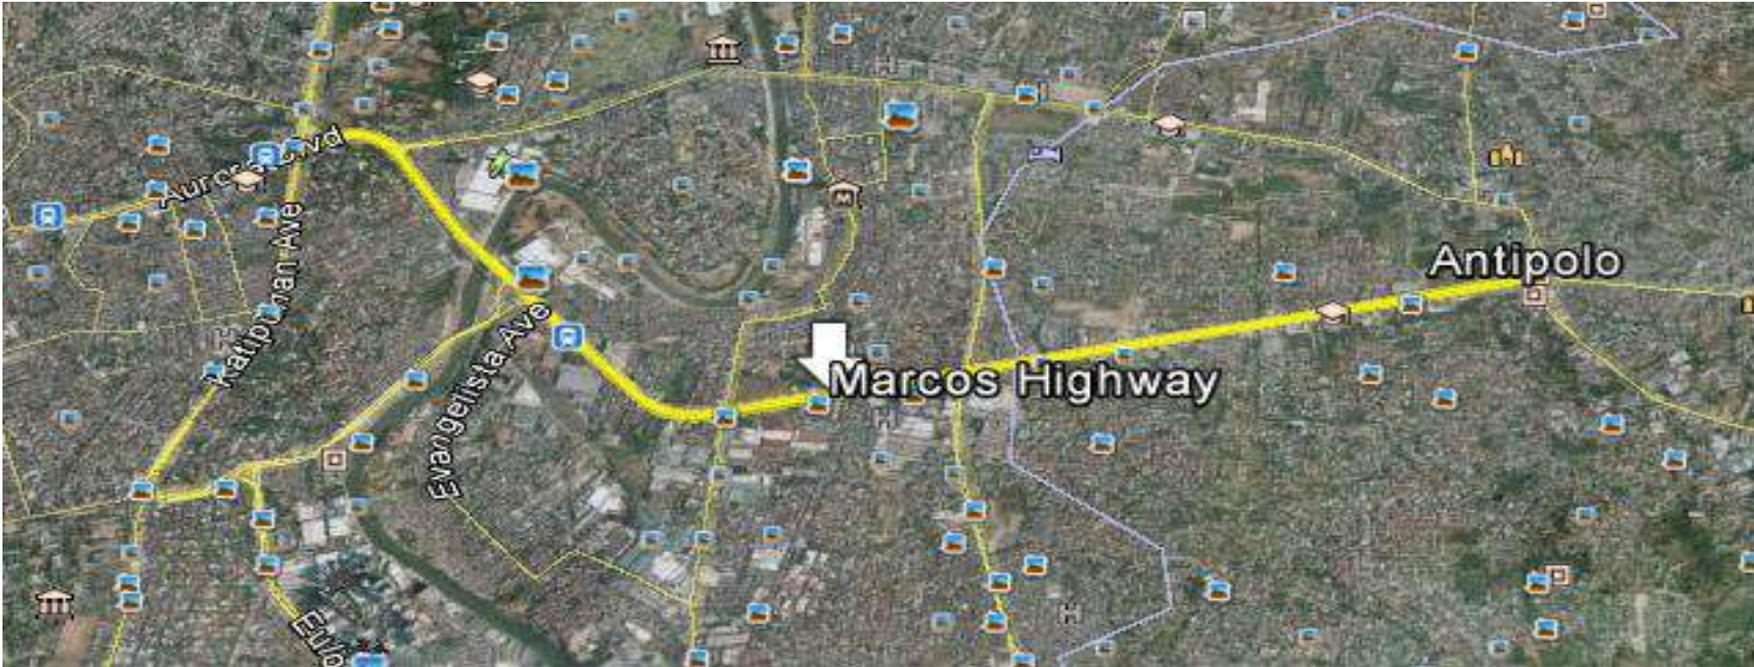
<b>Marcos Highway</b>
Starts at	14°35'19.29"N 121° 6'15.29"E Katipunan Avenue
Ends at	14°37'31.21"N 121° 7'28.12"E Masinag
Length	6.76km

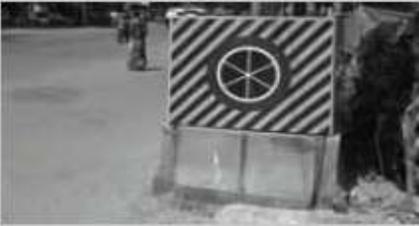
Rating	Description	Example
1	Pedestrian infrastructure is completely blocked by permanent obstructions

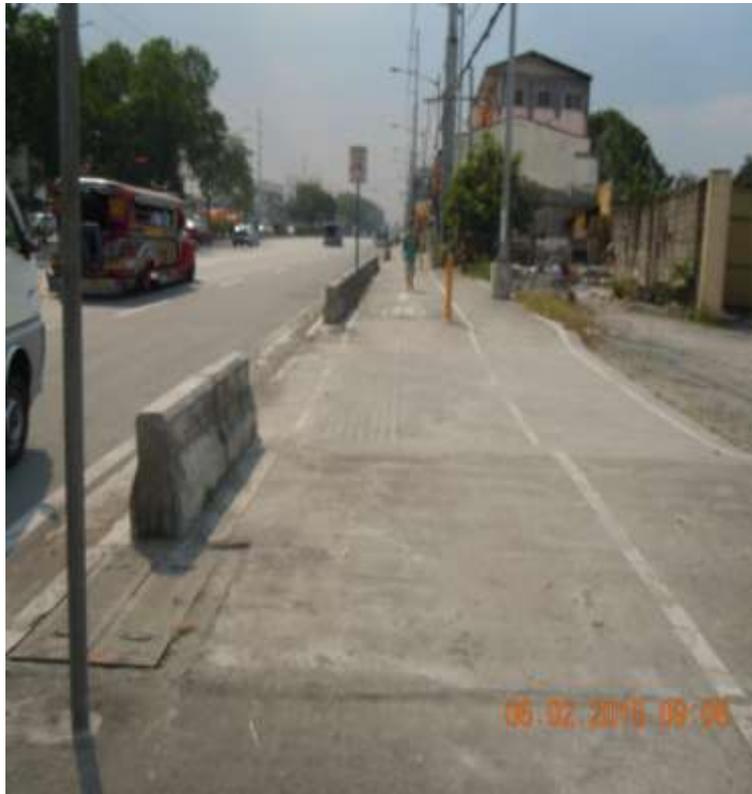
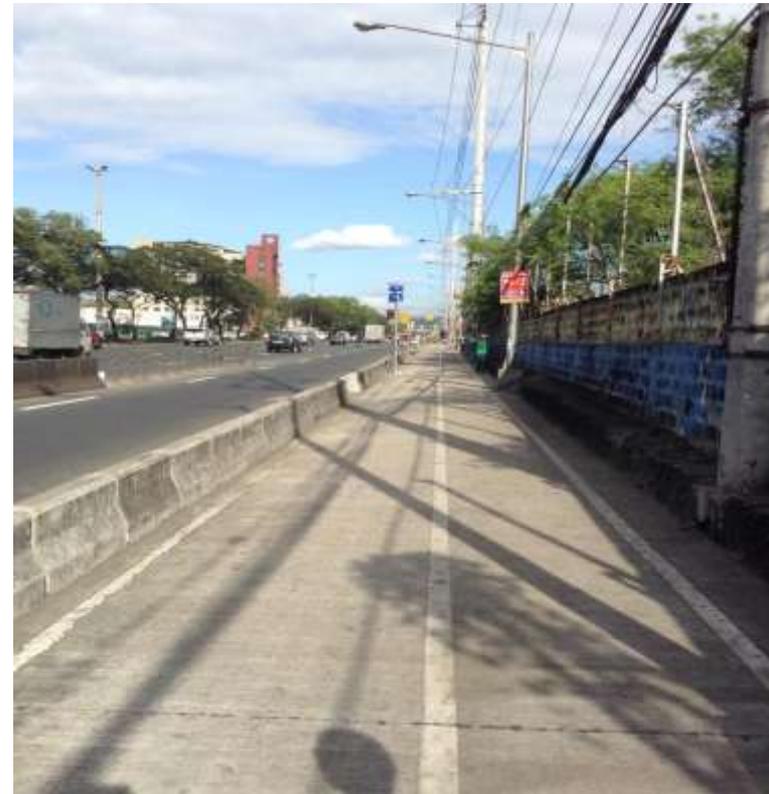
- Sidewalks

Westbound	Eastbound
5.71 km	5.43 km

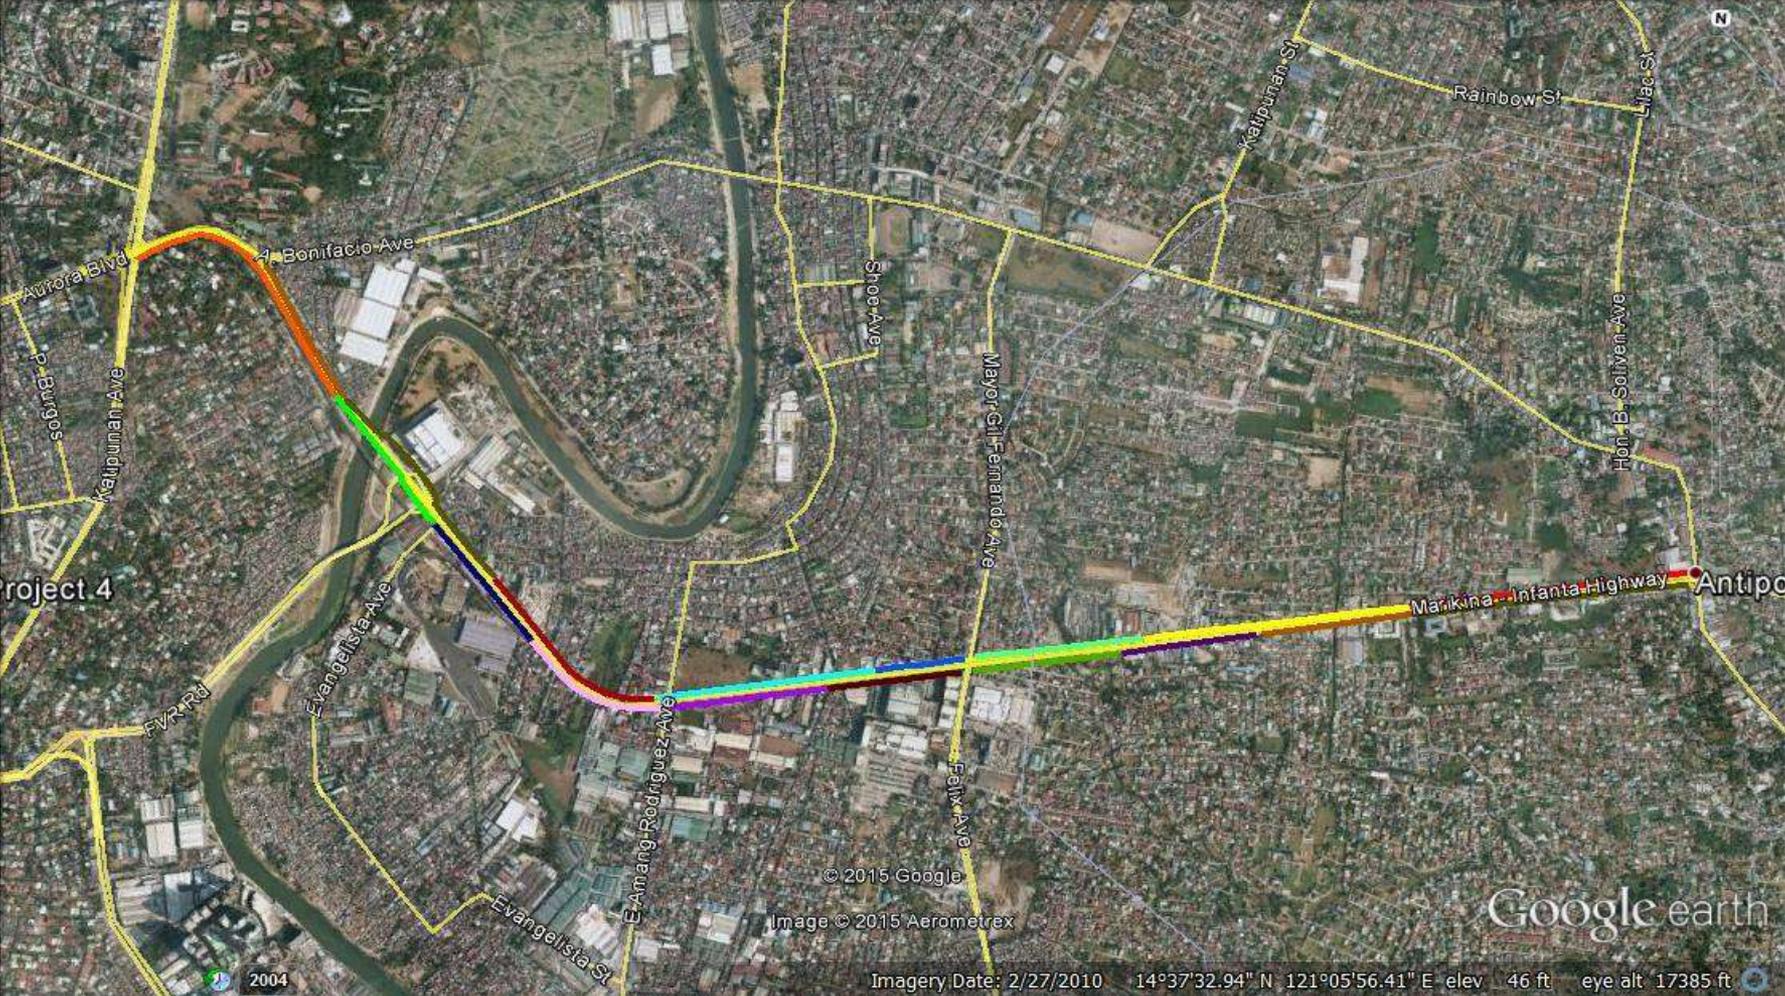
# Map Overview

# Road Stretches

Road Stretch No.	From	To	Length measured on field (km)
1	Katipunan	Maj. Santos Dizon St.	1.003
2	Maj. Santos Dizon St.	Evangelista Avenue	0.583
3	Evangelista Avenue	Petron	0.673
4	Petron	Amang Rodriguez Avenue	0.398
5	Amang Rodriguez Avenue	Bgy. Dela Paz	0.535
6	Bgy. Dela Paz	Sta. Lucia	0.46
7	Gil Fernando Avenue	Town and Country	0.498
8	Town and Country	Samsonville	0.461
9	Samsonville	AMA	0.523
10	AMA	Masinag	0.92
11	Masinag	Park Place	0.961
12	Park Place	Phoenix Fuel Station	0.907
13	PLDT	McDonald's	0.454
14	Gil Fernando Avenue	Caltex/Shell Station	0.307
15	Caltex/Shell Station	Ligaya	0.74
16	Ligaya	LRT Foot Bridge	0.73
17	LRT Foot Bridge	Start Marcos Bridge	0.842
18	Start Marcos Bridge	Monte Vista Footbridge	0.551

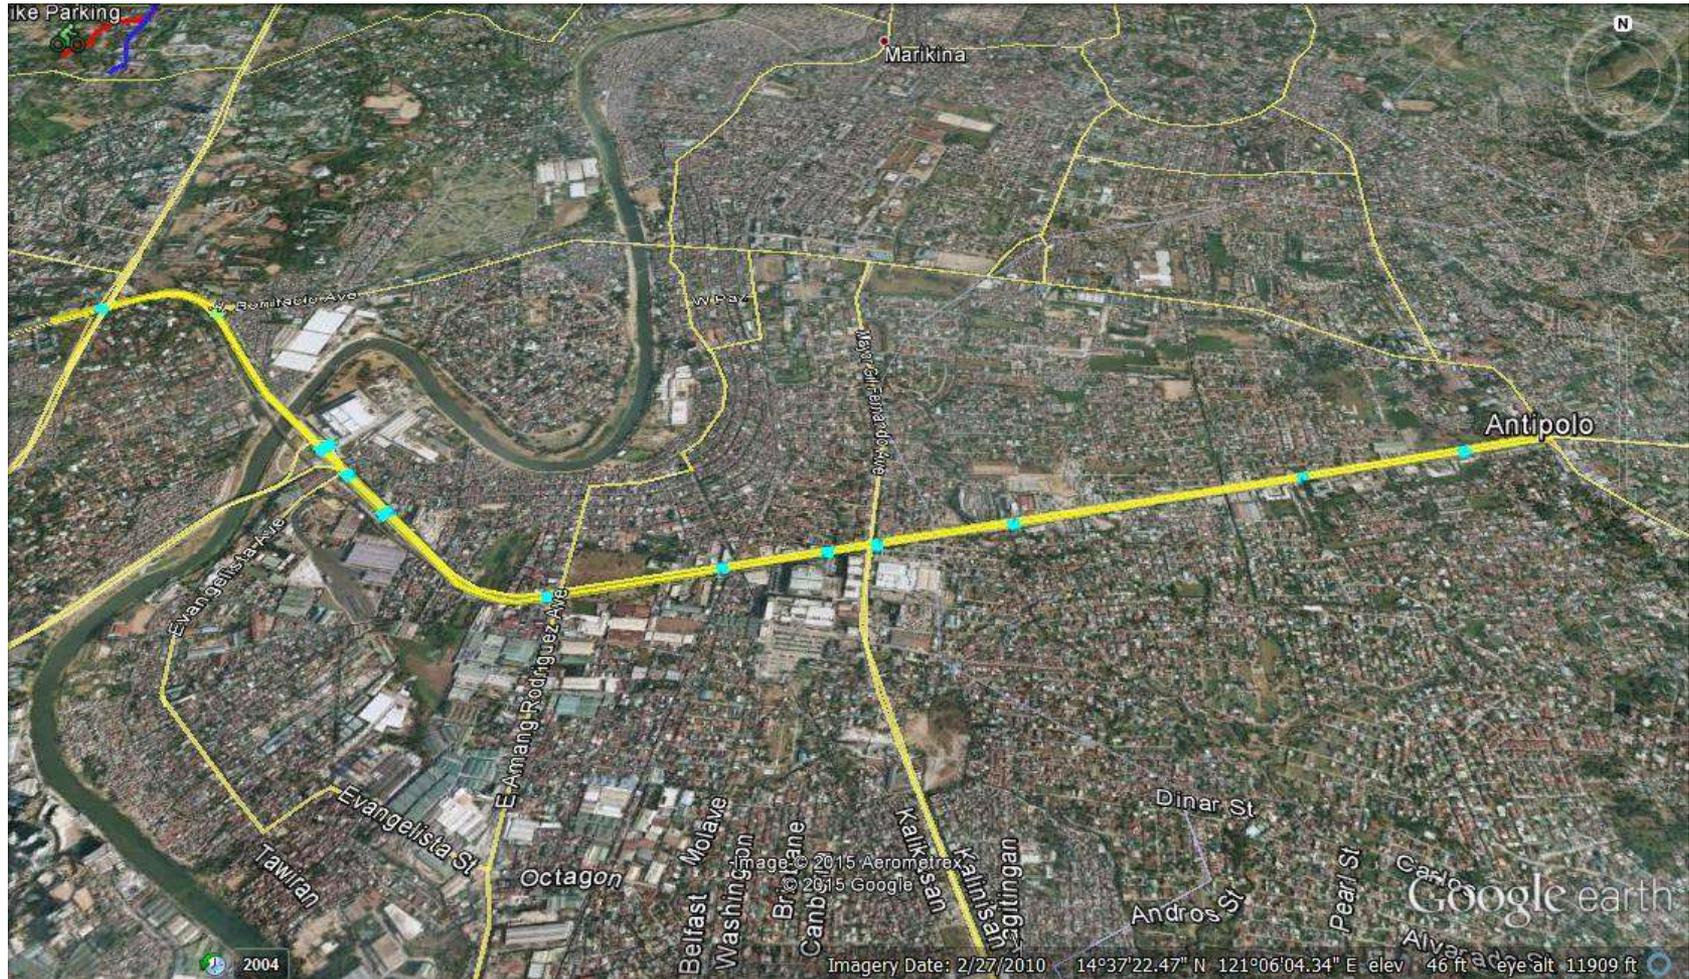
# Availability of Crossings

Footbridge Interval	Length (m)
1	496
2	942
3	178
4	244
5	751
6	565
7	346
8	164
9	472
10	1048
11	611
12	310

Stretch no.	Rating
1	1
2	1
3	2
4	1
5	1
6	3
7	2
8	1
9	1
10	2
11	2
12	1
13	2
14	3
15	1
16	1
17	2
18	1

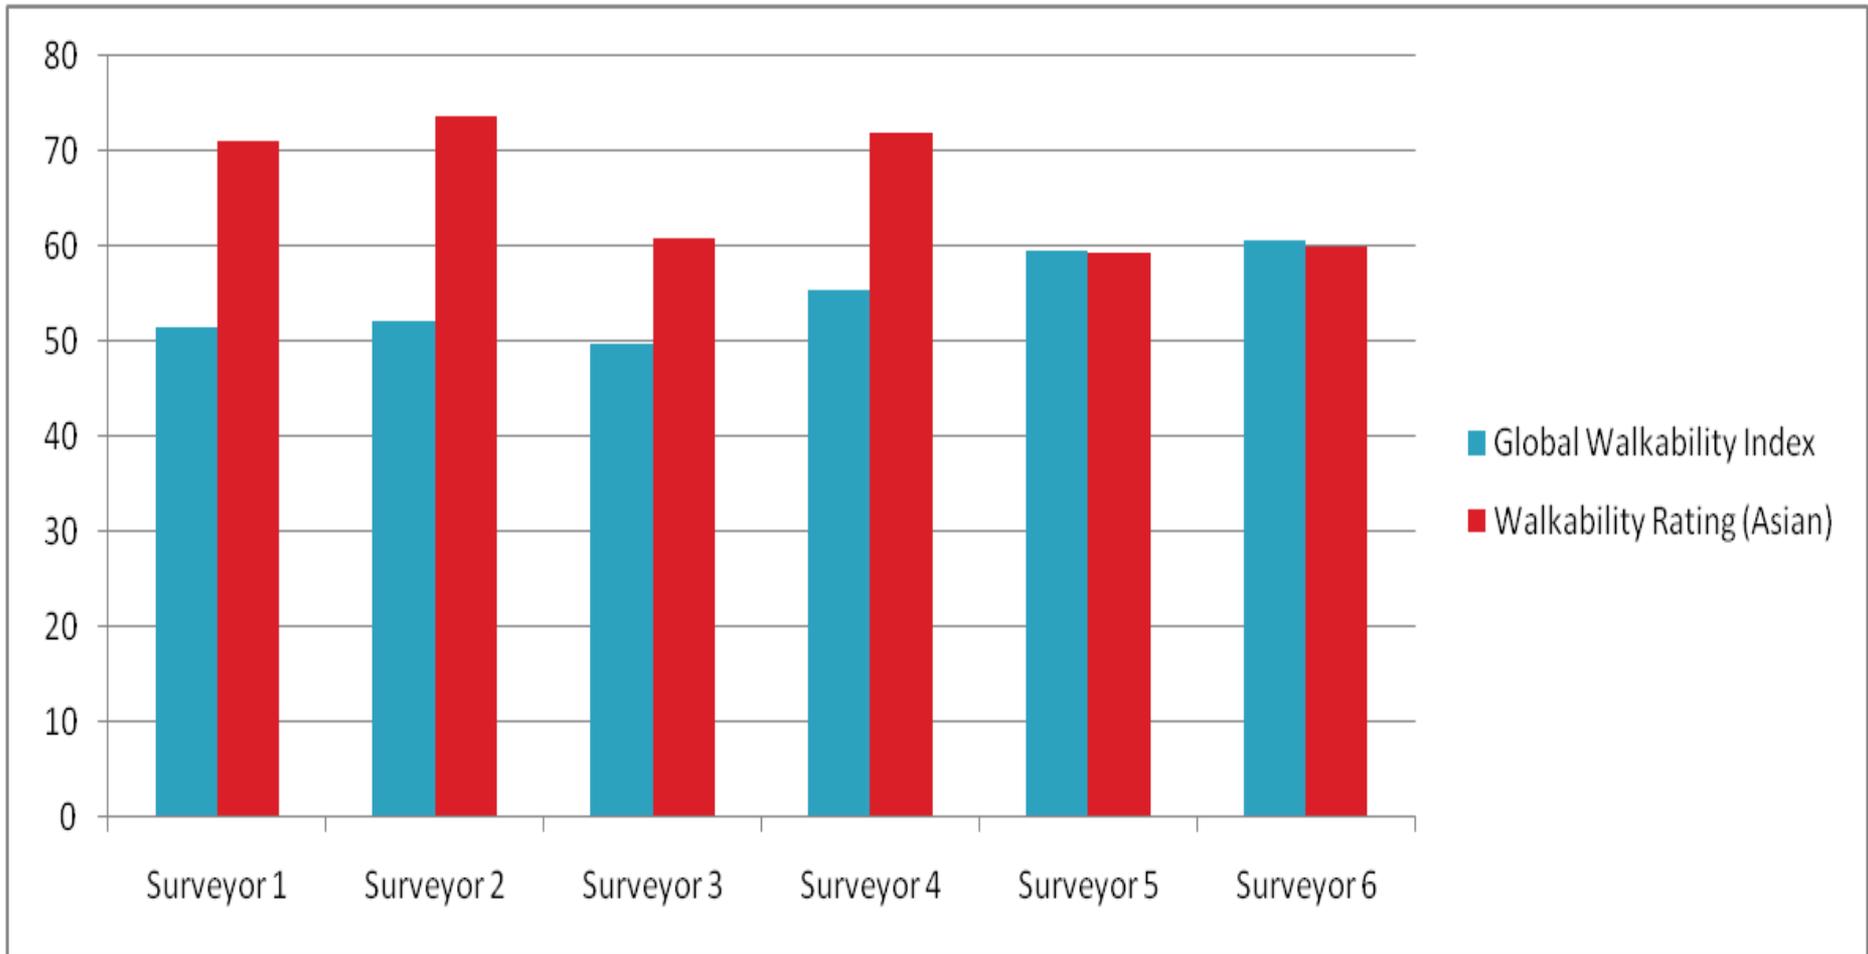
**Comparison of Overall Ratings for GWI and Asian Method**

Global Walkability Index
Surveyor 1	51.42%
Surveyor 2	52.09%
Surveyor 3	49.56%
Surveyor 4	55.24%
Surveyor 5	59.30%
Surveyor 6	60.55%
Marcos Highway Rating	54.69%
